# Plasma<sup>®</sup> High Performance Rope

Inspection Guidelines

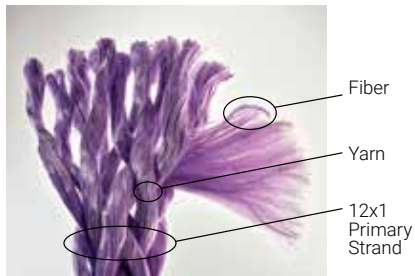
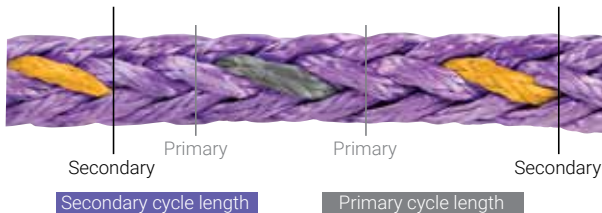
6 or more cut yarns within a Secondary cycle length—must repair or retire  
3 or more cut yarns within a Primary cycle length—must repair or retire rope

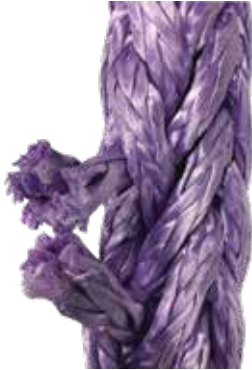
### **Distortion**

Reference retirement  
criteria #2

| | Condition | Remove from service |
|---|---|---|
| 2 | <b>Distortion of construction/Diameter inconsistency</b> | ✓ |

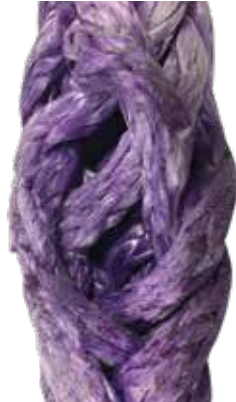
**Abrasion level 1:** normal wear—rope is showing normal wear, internal and external yarn shows light fuzziness and compression.

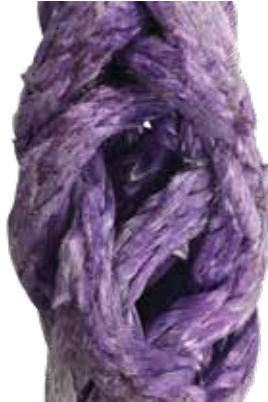
**Abrasion level 2:** normal wear—rope has more abrasion internally and externally, some slight total yarn volume loss, but rope is still good for use.

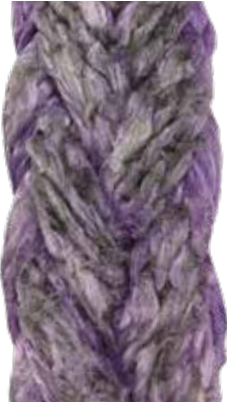
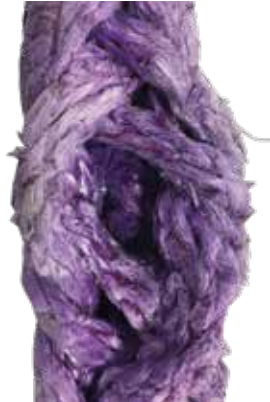
**Abrasion level 3:** normal wear—heavy internal abrasion, compression and diameter change. Carefully inspect for multiple cut yarns and full strands.

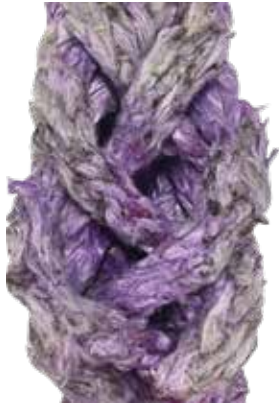
**Abrasion level 4:** caution—heavy internal abrasion and heat compression fusion of yarns. Also loss of fibers due to abrasion and cutting. Rope has probably lost a percentage of full new-rope strength. Carefully inspect for cut strands.

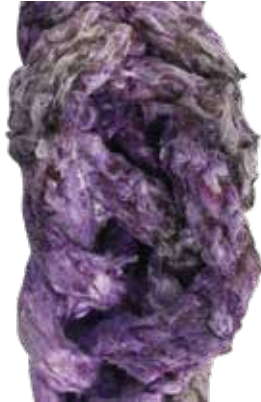
**Abrasion level 5:** remove rope from service—heavy external and internal heat compression, yarn volume loss and overall diameter size loss. Rope has lost a major percentage of its full new-rope strength.
